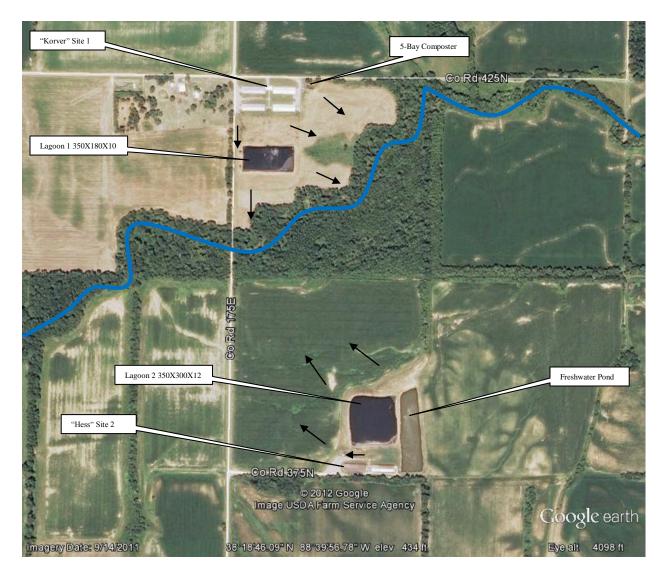
Arrows show the direction of storm water drainage. Four buildings at Site 1 "Korver" and two buildings at Site 2 "Hess" have combined capacities of 2800 and 1400 animals, respectively. Lagoon 1 located at Site 1 has the dimensions shown with a capacity of 1.6 million working gallons while Lagoon 2 located at Site 2 has the dimensions shown with a working capacity of 3.6 million working gallons. Mortalities are composted in a 5-bin composter located at Site 1. Four Mile Creek follows the path shown in blue westward between Site 1 and Site 2. There was no feed or discharge noted at either site during the inspection on 05/29/12.
